Airworthiness Directive

AD No.: 2023-0193

FB6 Double Burner Assembly

ATA 28 – Fuel – Hot Air Balloon Burner Assembly and Hanger – Inspection / Modification

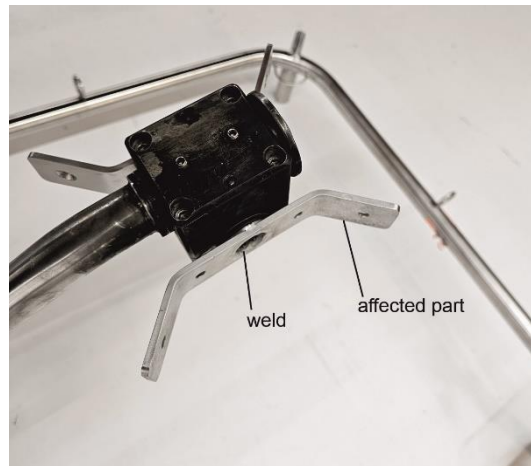
Figure 1 – Affected Part

Affected part: Connector of FB6 double burner hanger, except a serviceable part. See Appendix 1 to this AD.

An occurrence was reported of a burner type FB6 S/N 2.1239-1 where the connector between the burners was found detached during transportation, leaving one burner unit detached from the load frame. Investigation revealed that the welding process may have been improperly done, due to an insufficiently detailed description of that process in production. The suspected direct cause of failure is fatigue cracking of the weld, mainly due to improper handling during transportation.

- (2) If, during the inspection as required by paragraph (1) of this AD, any crack is detected or evidence of a weld with insufficient filler material is found, before next flight, replace the affected part with a serviceable part, in accordance with the instructions of the TN.
